URGENT Medical Device Correction

M5071A (adult) and M5072A (infant/child) pads for use with HS1/OnSite/Home AEDs may experience gel separation and reduction of gel surface area

22-FEB-2022

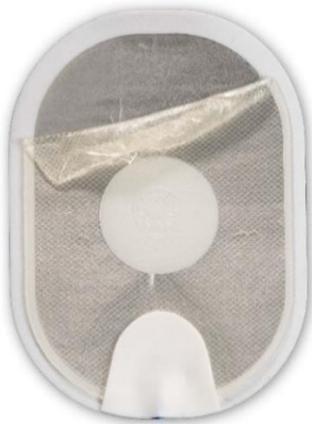
When a pad with separated, folded gel is placed on the patient's bare skin, the HS1/OnSite/Home AED could deliver less effective or ineffective therapy to the patient due to the reduced surface contact area with the skin. See example picture in **Figure 1**.

Figure 1: Separated gel that has folded onto itself when peeled.

Action:
Apply pads to the patient.
Do not hesitate.

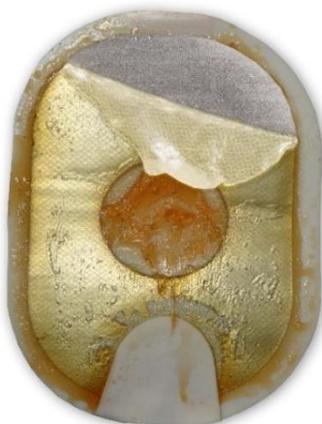
Separated, folded gel may also have a discolored and/or melted appearance. While the gel may also have a discolored and/or melted appearance, the appearance does not have any impact on the delivery of therapy;

however, there may be a delay in therapy if the user hesitates to apply the pad due to its appearance, and the AED may deliver less effective or ineffective therapy to the patient due to the reduced contact area with the skin. See example picture in **Figure 2**.

Figure 2: Separated, folded gel may also have a discolored and/or melted appearance.

Action:
Apply pads to the patient.
Do not hesitate.

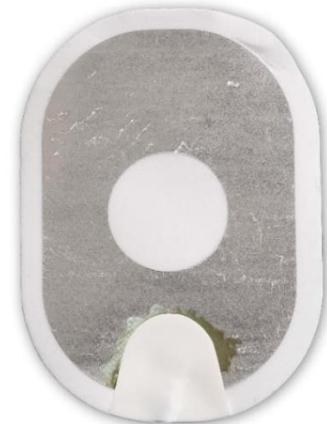
It is also possible that the gel could separate almost completely from the foam/tin backing when peeled, (see **Figure 3**.) Due to a small amount of gel surface contact area with the skin, electrical arcing could occur when a shock is delivered leading to burns to the patient's skin, or the AED could be unable to deliver any shock through the pads. A delay in therapy will result while the user installs a replacement pads cartridge (if available) or performs CPR while waiting for Emergency Medical Services Personnel to arrive. For comparison, **Figure 4** shows a normal pad. No matter the state of the pad, follow the voice prompts because the AED will step you through the necessary actions.

Figure 3: Gel almost completely separated from backing.

Action:
Replace pads cartridge if a spare is available. If no spare is available, perform CPR until help arrives.

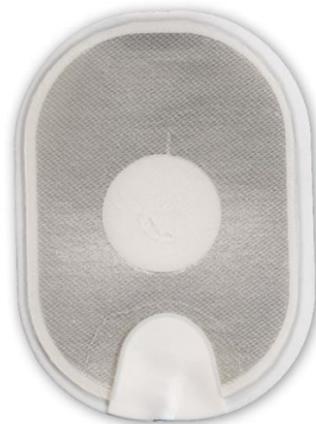
Figure 4: Normal pad. ✓

Action:
Apply pads to the patient according to the Instructions for Use/Owner's Manual.
